Report No. : PN:EE:1456003840

SAMPLE DESCRIPTION MODIK Wall Mounting Box Enclosure
PART NO 795 030
COLOUR RAL 7035
OEM OTHERS
COUNTRY OF ORIGIN Sri Lanka
DATE OF REGISTRATION 30/12/2023
TEST(S) REQUESTED SALT MIST TEST

Test name	Test method
Salt mist test	IEC 60068 – 2 - 11 : 2021 AS specified by the customer

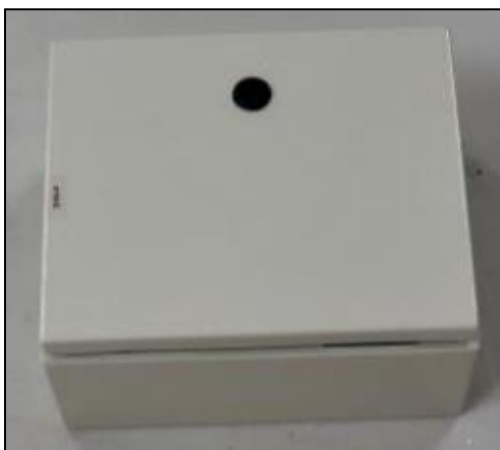
Fig 1 – DUT as received

DUT Name	MODIK Wall Mounting Box Enclosure
Part No	795 030
H/w number	--
s/w number	--
No. of DUT	01
DUT operating voltage	--
DUT condition	DUT received in good condition

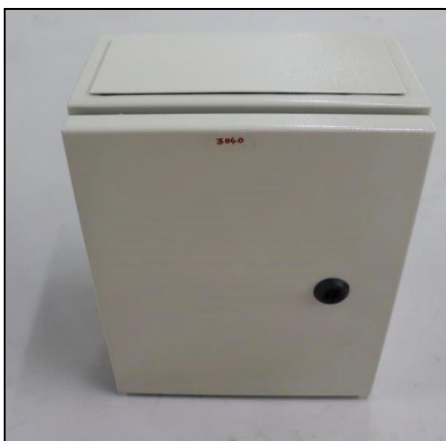
Fig 04 – DUT after test

Test name	Test method	No. of DUT	Testing period	Result	Remark
Salt mist test	IEC 60068 – 2 - 11 : 2021 AS specified by the customer	01	24/04/2024 to 03/05/2024	Pass	Tested samples meets the test requirement

Time intervals (Hours)	Visual observation
24	No sign of rust observed
48	No sign of rust observed
72	No sign of rust observed
96	No sign of rust observed
120	No sign of rust observed
144	No sign of rust observed
168	No sign of rust observed
192	No sign of rust observed
200	No sign of rust observed
