Report No. : PN:EE:1456003839

SAMPLE DESCRIPTION	MODIK OUTDOOR FREE-STANDING ENCLOSURES
COLOUR	RAL 7035
PART NO	769 010
OEM	OTHERS
COUNTRY OF ORIGIN	SRI LANKA
DATE OF REGISTRATION	30/12/2023
TEST(S) REQUESTED	SALT SPRAY TEST

Test name	Test method
Salt spray test	IEC 60068 – 2 - 11 : 2021 AS specified by the customer

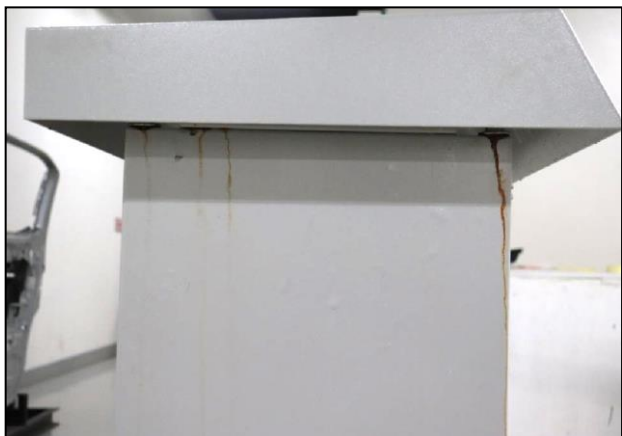
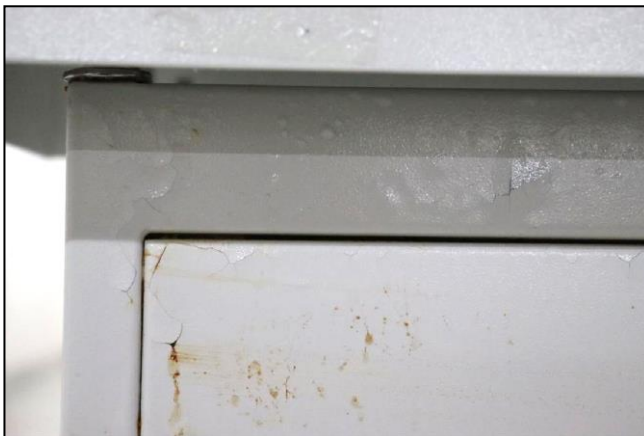
Time intervals (Hours)	Visual observation
312	No sign of rust observed
336	No sign of rust observed
360	No sign of rust observed
384	No sign of rust observed
408	No sign of rust observed
432	No sign of rust observed
456	No sign of rust observed
480	No sign of rust observed
504	No sign of rust observed
528	No sign of rust observed
552	Red rust and coating ped off observed
576	Red rust and coating ped off observed
600	Red rust and coating ped off observed

Fig 03 – DUT after the test (Red rust and coating ped off observed)
