| <b>Prüfbericht-Nr.:</b><br><i>Test report no.:</i> | <b>IN24OB9F 001</b> | <b>Auftrags-Nr.:</b><br><i>Order no.:</i> | <b>146845757</b> | Seite 1 von 7<br>Page 1 of 7 | | | |
| <b>Prüfgegenstand:</b><br><i>Test item:</i> | <b>Outdoor Electrical Panels, Battery Cabinets, 19" Racks</b> | | | | | | |
| <b>Bezeichnung / Typ-Nr.:</b><br><i>Identification / Type no.:</i> | <b>MODIK Outdoor Free Standing Enclosures</b> | | | | | | |
| <b>Auftrags-Inhalt:</b><br><i>Order content:</i> | <b>Testing And Issue of Test Report</b> | | | | | | |

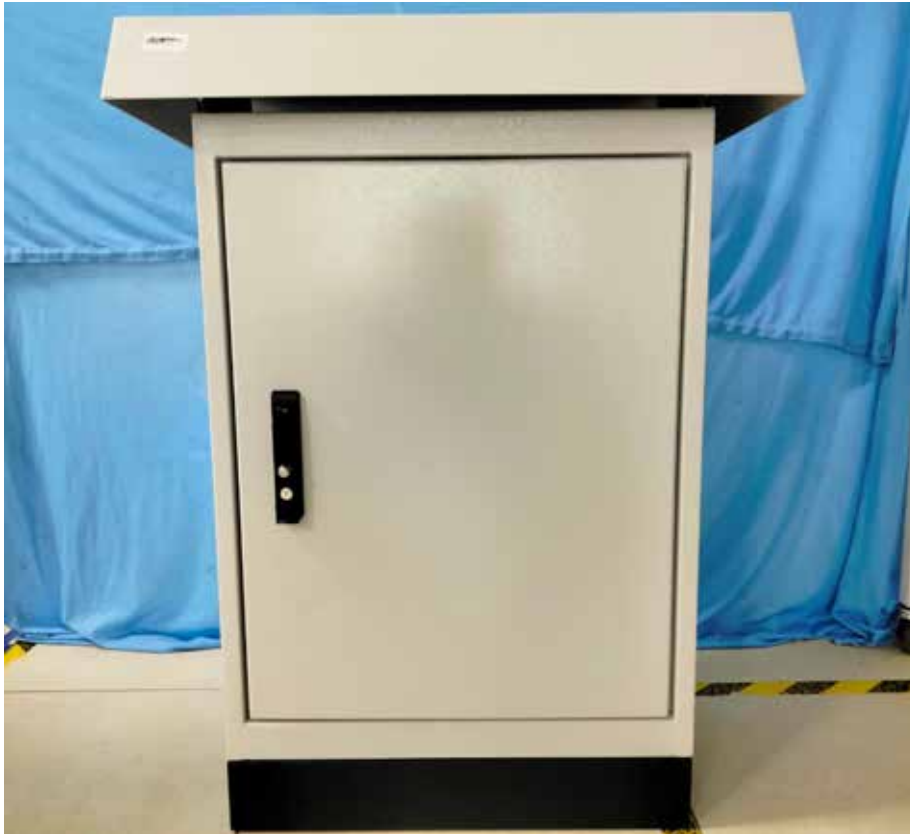
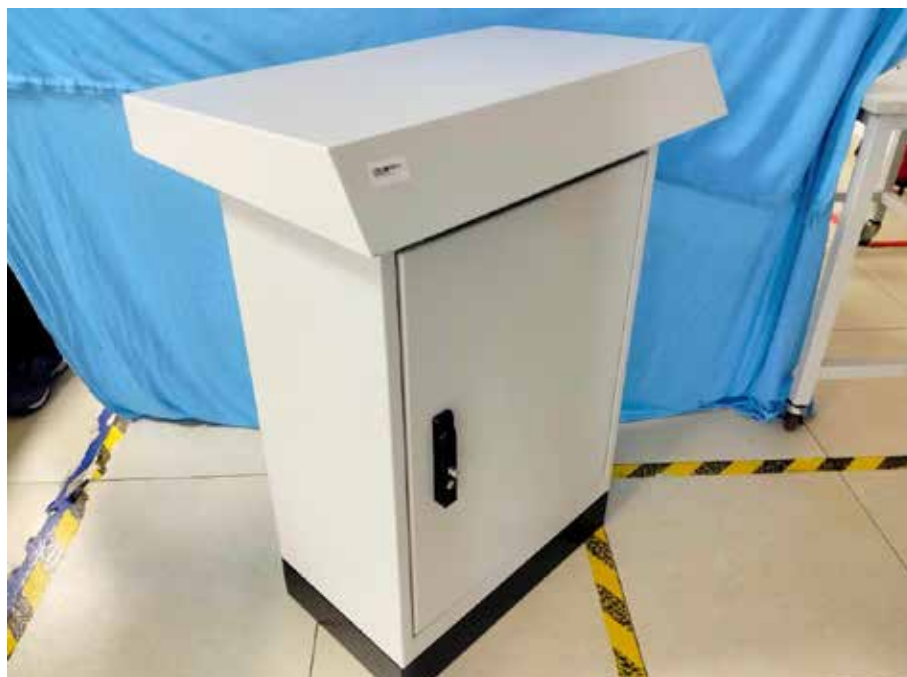
EUT Overall

| <b>2</b> | <b>Maße / Gewicht</b><br><i>Dimensions / Weight</i> | 600 x 800 x 350mm |
| <b>5</b> | <b>Verwendete Materialien</b><br><i>Used materials</i> | Electro Galvanized Steel |

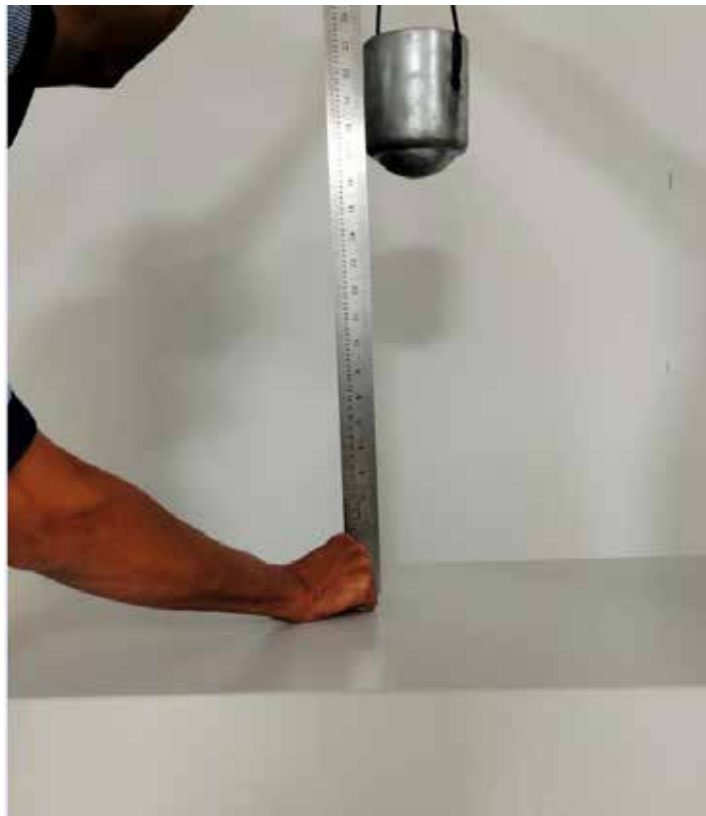
IK08 Test Setup

| Absatz<br>Clause | Anforderungen - Prüfungen /<br>Requirements - Tests | Messergebnisse – Bemerkungen/<br>Measuring results - Remarks | Ergebnis<br>Result |
|---|---|---|---|
| | Impact Energy | 20 J | - |
| | Drop height | 400 mm | - |
| | IK Class | 10 | - |
| | Number of Impact | 3 impact per location | - |
| | Impact locaion | 5 sides of EUT (Front, Back, Right, Left, Top sides) | - |

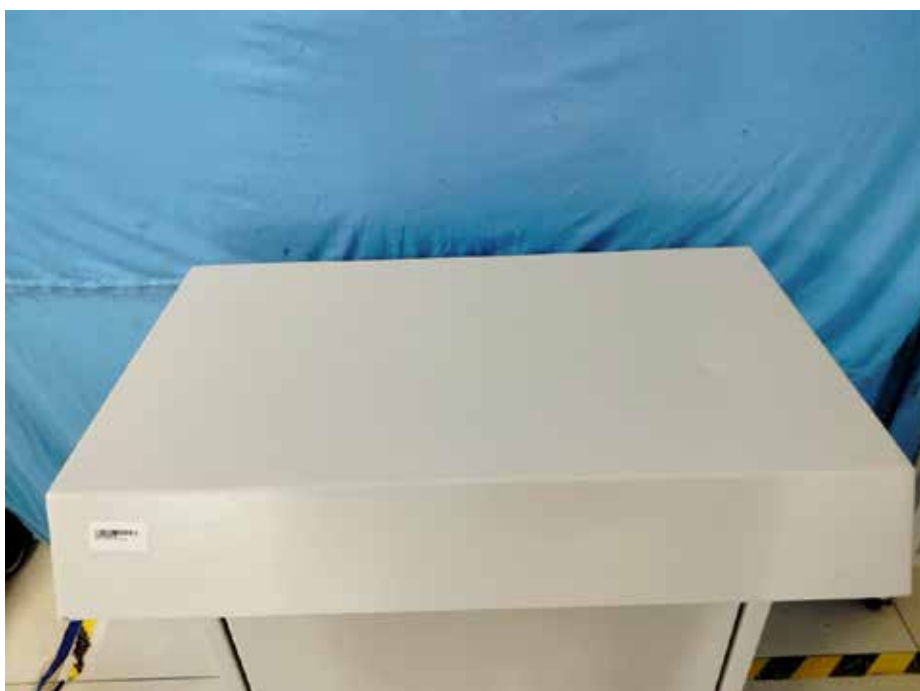
Post test observation

| Absatz<br>Clause | Anforderungen - Prüfungen /<br>Requirements - Tests | Messergebnisse – Bemerkungen/<br>Measuring results - Remarks | Ergebnis<br>Result |
|---|---|---|---|
| | Physical checks | No physical damages/cracks observed on the EUT after the test. | P |
