## TEST REPORT

Test Report No: A1M231028006/M231028006-11

MODIK Wall Mount Box Enclosure (WXHxD 250X300X150mm)

### **1. DEGREE OF PROTECTION AGAINST MECHANICAL IMPACTS IK-08**

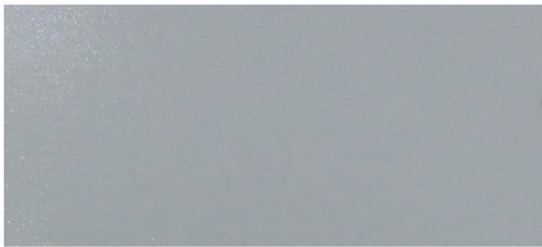
Sample Before Test	Sample After Test

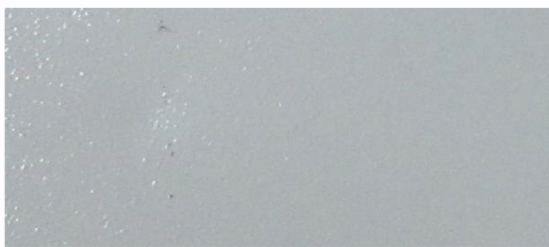
1. Test Specification: - IEC 62262: 2002
2. Reference Test Method: - IEC 60068-2-75: 2014
3. IK Code: - IK 08
4. Ambient Condition: - Temperature: 26°C & Air pressure: 978 mbar
5. Impact Energy: - 5 Joules
6. Test Equipment: - Free fall hammer
7. No. of specimen: - 1
8. Support: - The enclosure was mounted on a rigid support
9. Striking Hammer: - Height of fall: 300 mm & Equivalent weight: 1700 gm
10. Application of blows/impacts: - 5 impacts on each exposed face. The impacts were evenly distributed on the faces of the enclosures.
11. **Observations: - No admissible damage observed after the test.**
12. **Remark: - "PASS"**
